# Failure Analysis Control Board Project

## Early Failures Detected

### / Approach: Temperature Humidity Bias (THB) Test Setup

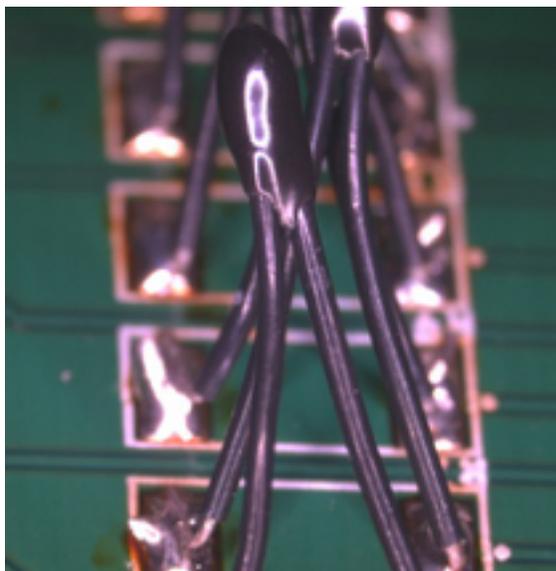
Thermistor prior to decapsulation

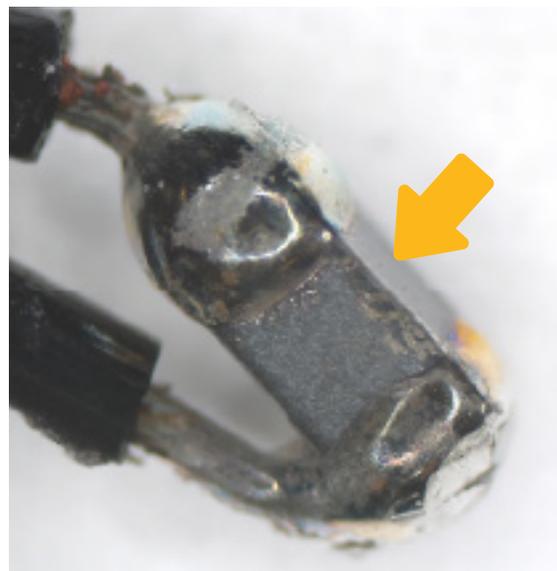
The thermistors resulting in failure were decapsulated through an iterative process of using an epoxy-specific solvent on a hot plate. Our engineers immediately noticed signs of an unknown material between the terminations while looking at the samples under the optical microscope.

Thermistor post-decapsulation under optical microscope

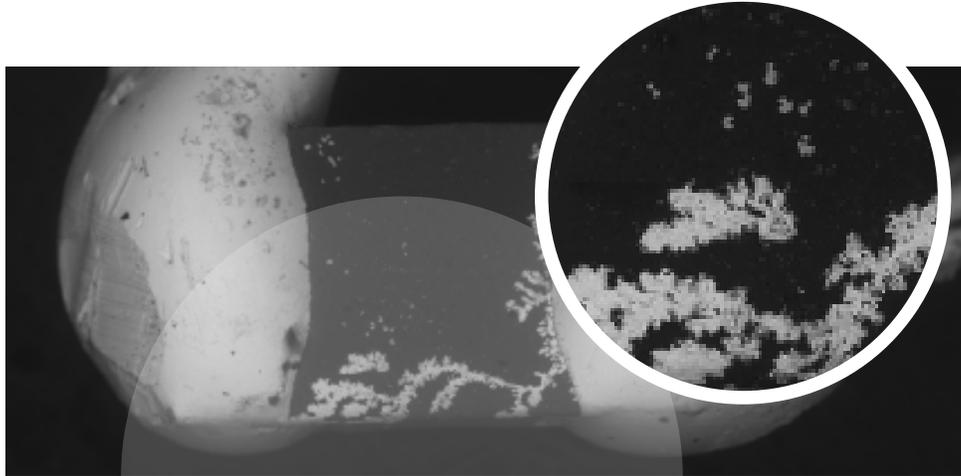
In the scanning electron microscope (SEM), the images collected show signs of migration — dendritic growth shorting the two terminations.

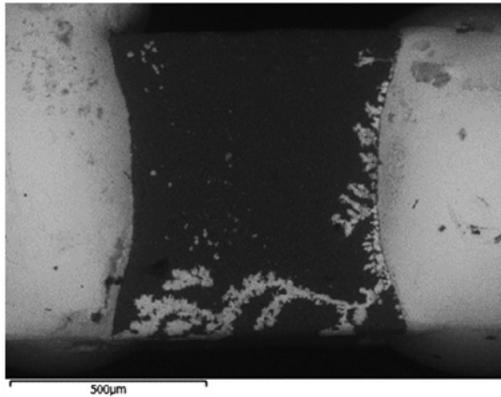
ELECTRON IMAGE

Furthermore, energy dispersive X-ray spectroscopy (EDS) analysis helped confirm the presence of the dendritic growth that was seen in the SEM images. Areas of high nickel and copper corresponded with regions of terminals that had depleted tin. This combination of SEM and EDS analysis highlighted evidence of migration of tin, which lead to shorting between the two terminals of the thermistor.

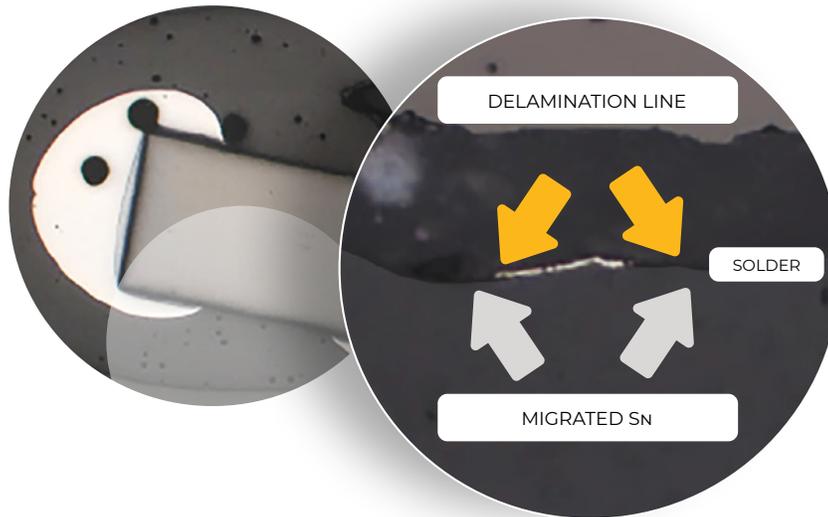
Cross-sectioning revealed scattered voiding in the epoxy encapsulant, including a void close to the interface of the epoxy and thermistor body. Voiding along the epoxy/thermistor interface makes the device susceptible to delamination and moisture ingress, creating the environment needed for dendritic growth under bias.

*The images below reveal an apparent demarcated line on the bottom side of the component, confirming signs of tin migration.*

Both decapsulation and cross-sectioning showed signs of electrochemical migration of tin in multiple components that failed temperature humidity bias testing. Additionally, cross-sections showed signs of a thin delamination line at the epoxy/thermistor interface caused by tin migration, further indicating the presence of moisture ingress and delamination to allow dendritic growth.

Ansys-DfR primary recommendation was to switch to the second thermistor supplier. As an alternative, we recommended verifying whether baking the current thermistors for 24 hours at 105 C would improve THB performance (by removing suspected initial moisture). However, a follow-on project showed that even baking did not eliminate failures.
